^{Proposal for} 130 Queen Quay East - Terrace and PG

Site Address 130 Queen Quay East

Proposal numbe 465

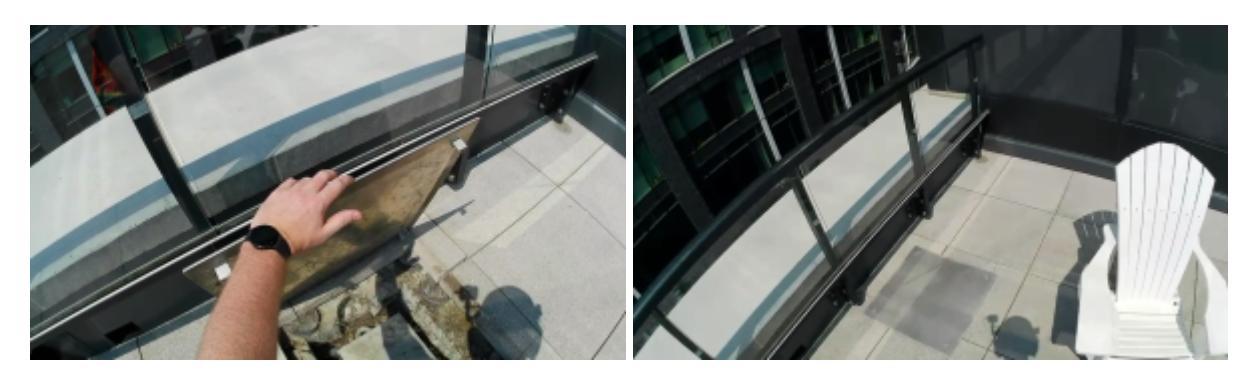
Cracked and Loose Pavers Issue

1. Paver Removal	¢ 40 / 0	Sub Total: \$ 64
L 2 W 2 4 sq ft	\$ 16 / sq ft	
2. Paver Resetting	\$ 10 / sq ft	Sub Total: \$ 40
L 2 W 2 4 sq ft		
3. New Paver Installation	\$ 13 / sa ft	Sub Total: \$ 52

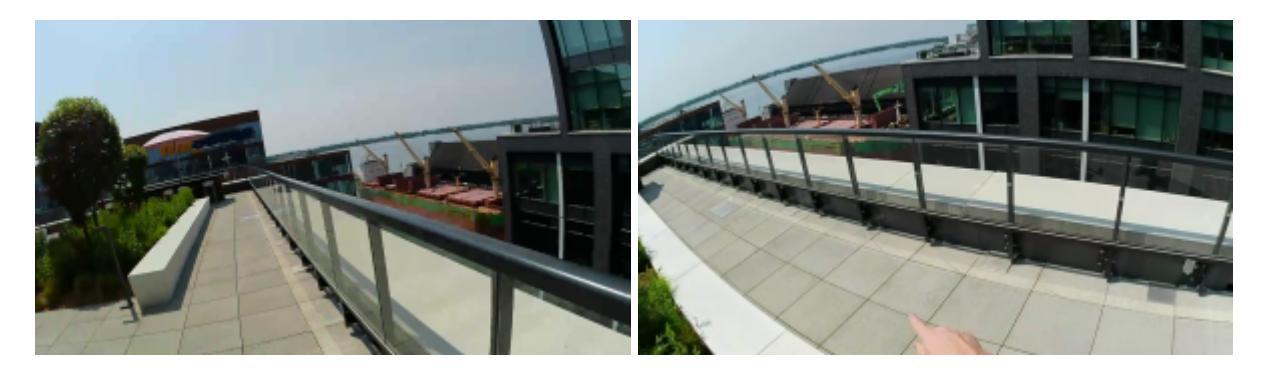
Exterior Wall Cold Joint Issue on Western Wall

1. Cold Joint

L 56 56 ft

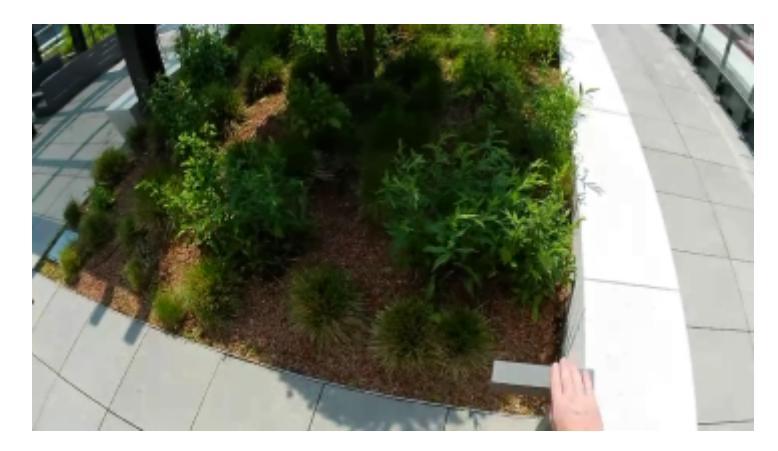
Loose Light Bollards Issue

1. Post/bollard adjustment

Note: Need to fix 10 bollards

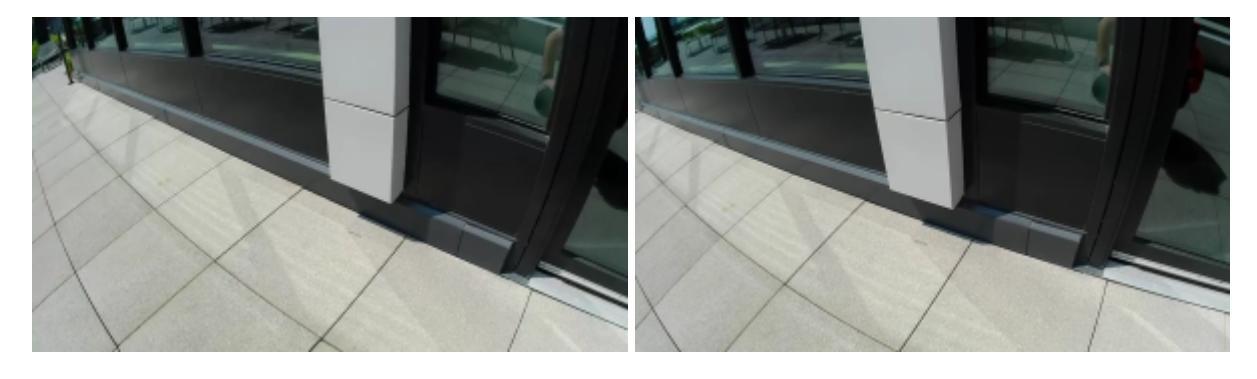
Cold Joint Issue in Conference Room

1. Cold Joint

L 24 24 ft

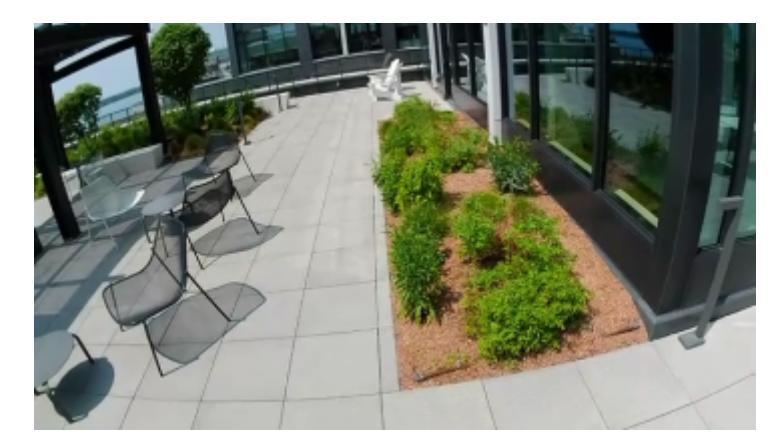
Damaged Garden Membrane Issue

1. Earth/Pebble Removal	¢ 4 / as the sub-table ¢ 576
L 6 W 24 144 sq ft	Φ 4 / sq π Sub lotal: Φ 37 0
2. Epoxy Removal	¢ 4 2 / or ft Sub Total ¢ 605
L 6 W 24 144 sq ft	φ 4.2 / sq π - Sub lotal: φ 003
3. Grinding (General)	¢ 4 0 / or ft - Sub Total ¢ 706
L 6 W 24 144 sq ft	5 4.9 / sq π Sub lotal: 5 706
4. Surface Coating Epoxy	¢ 12 / an ft - Cult Tataly ¢ 1 720
L 6 W 24 144 sq ft	φ 12/ sq π Sub lotal: \$ 1,720

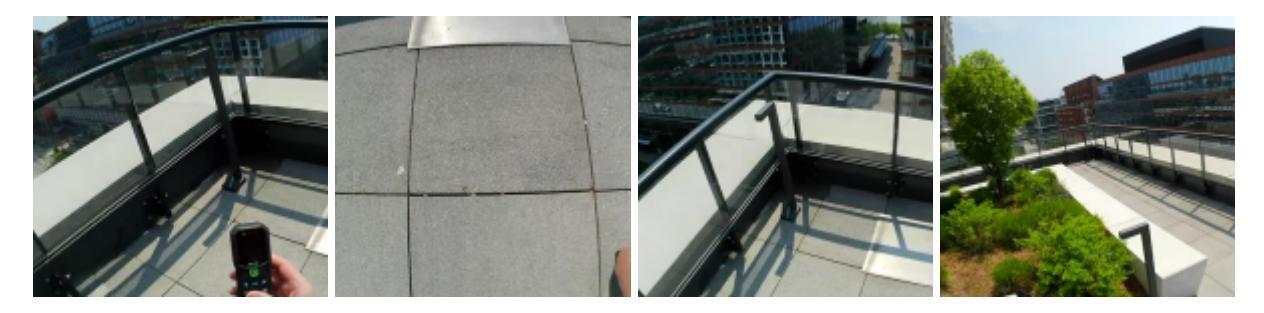
Southeast Corner Water Pooling Issue

1. Paver Removal	• 10 / · · ·	Sub Total: \$ 576
L 6 W 6 36 sq ft	\$ 16 / sq ft	
2. Surface Resloping	\$ 6 / sq ft	Sub Total: \$ 216
L 6 W 6 36 sq ft		
3. Paver Resetting	\$ 10 / sq ft	
		Sub Iotal: \$ 360

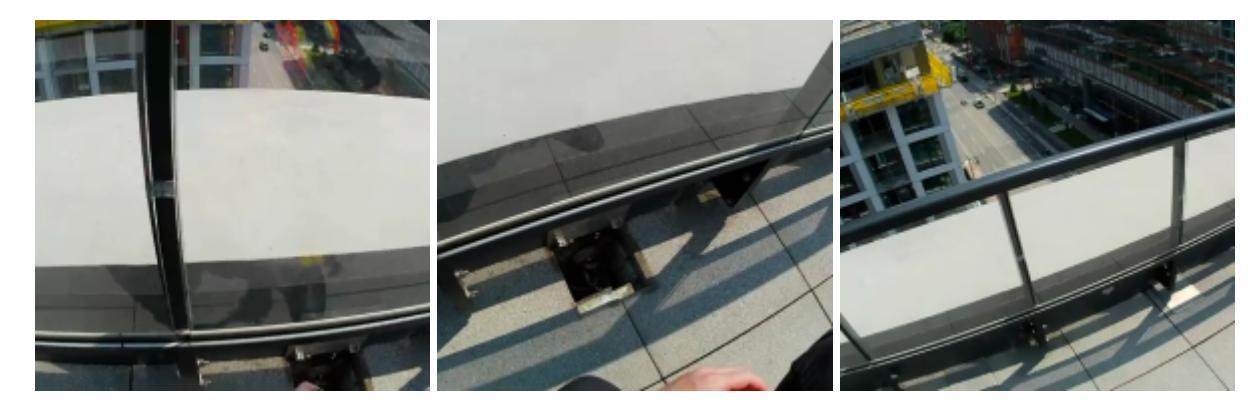
Waterproofing Anchor Points

1. Caulking

L 24 24 ft

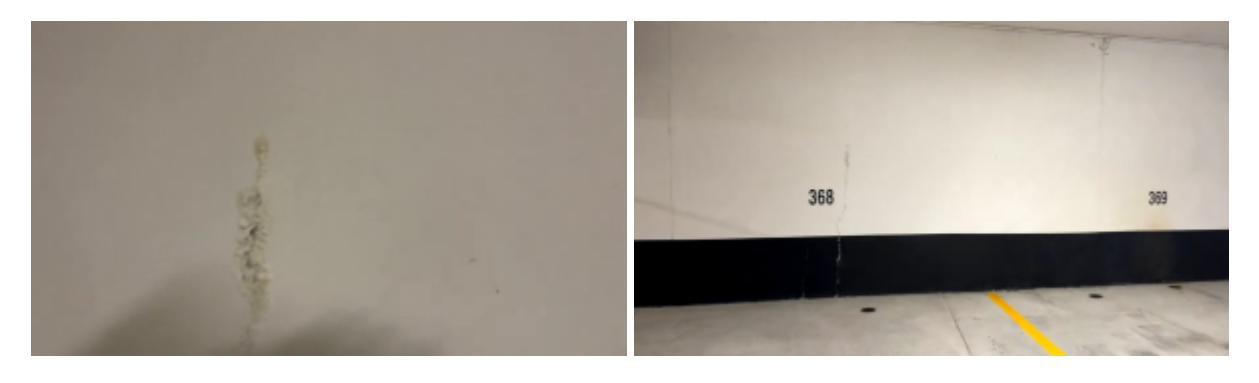
Foundation Issue at Spot 368

1. Cold Joint

L6 6 ft
