Technical Overview (Proposal Summary Document) for

130 Queen Quay East - Terrace and PG

130 Queens Quay E

465

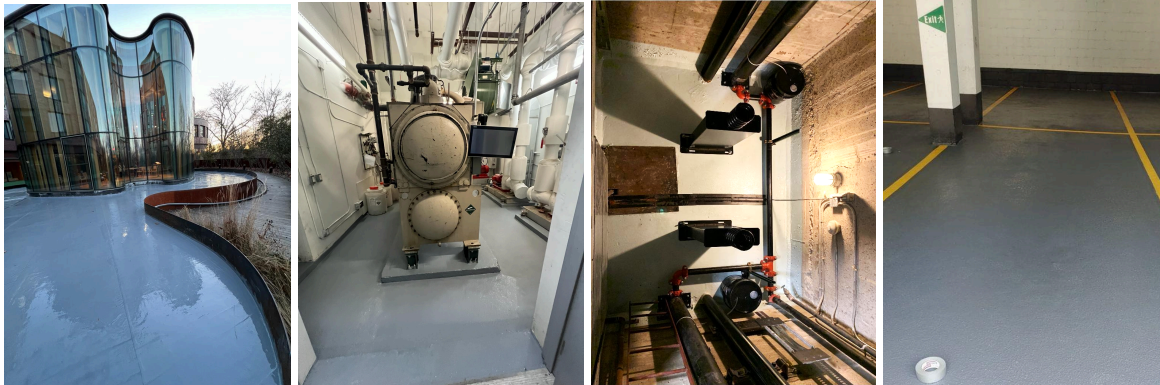
Coating - Waterproofing Membrane

Applying a waterproofing membrane in two layers, integrated with non-slip aggregates, offers a robust solution for enhancing surface durability and safety. The repair begins with surface preparation: grinding is done to eliminate any loose material and ensure proper adhesion of the membrane. The first membrane layer acts as a base, providing a resilient foundation for the subsequent application. Non-slip aggregates are then incorporated into the second layer to enhance traction and prevent slips and falls, followed by a second layer of the membrane.

This dual-layer approach not only reinforces the surface against wear and tear but also enhances safety by reducing the risk of accidents. Overall, the application of a waterproofing coating with non-slip aggregates, preceded by thorough surface grinding, results in a durable, high-traction surface suitable for various commercial, industrial, and residential settings.
